On April 20, 2002, 1st Battalion, 2nd Aviation Regiment, Camp Page, Korea, experienced a potentially catastrophic inflight event while conducting AH-64D aerial gunnery operations. As the aircraft maneuvered into firing position, it began an uncommanded right yaw. Confirming that the turn was not copilot/gunner-induced and that neither station could move the pedals, the crew determined that they were experiencing a fixed-pitch

Boeing's on-site field support representative issued a "flash mishap report," which described the incident and its suspected root cause. At the Boeing Mesa facility in Arizona, all production line aircraft were immediately inspected. The inspection results were noteworthy for several reasons. First, it was determined that the jumper cable routing was clearly problematic

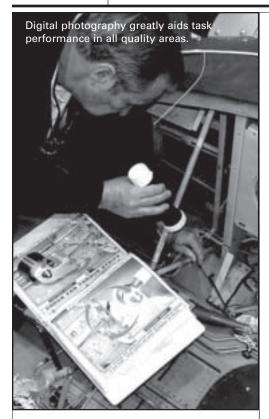
All SOF inspections are covered by this enhanced approach to quality assurance surveillance.

(i.e., allowed cable travel). Furthermore, this condition was found to be "not to print." Most significantly, the condition was present on 20 of the 22 aircraft inspected. Inspectors found that the jumper cables had been improperly routed beneath or behind the ARDD assembly. Blueprints depicted that cables should be routed in front of and above the assembly.

The follow-on review revealed the source of the assembly procedure error. Although assembler and quality inspector misinterpretation were clearly factors in this shortcoming, the blueprint/drawing also played a role. Simply put, the drawing did not adequately depict the true/correct jumper cable routing for the ARDD assembly. Though in fact installed incorrectly, the cable routing "looked right" to the trained eye and appeared to have more than adequate clearance past the ARDD assembly. Under static factory assembly conditions, and follow-on functional checks, the potential for cable travel and subsequent fouling within the ARDD assembly occurred to
